**DEPARTMENT OF TRANSPORTATION**

Quality Assurance and Source Inspection

Contract #: 04-0120F4Cty: SF/ALA Rte: 80 PM: 13.2/13.9File #: 13.28**WELDING INSPECTION REPORT****Resident Engineer:**Pursell, Gary**Address:** 333 Burma Road**City:** Oakland, CA 94607**Report No:** WIR-008643**Date Inspected:** 24-Aug-2009**Project Name:** SAS Superstructure**OSM Arrival Time:** 700**Prime Contractor:** American Bridge/Fluor Enterprises, a JV**OSM Departure Time:** 1530**Contractor:** Oregon Iron Works Clackamas, Or.**Location:** Clackamas, OR**CWI Name:** Mike Gregson, Jose Salazar**CWI Present:** Yes No**Inspected CWI report:** Yes No N/A**Rod Oven in Use:** Yes No N/A**Electrode to specification:** Yes No N/A**Weld Procedures Followed:** Yes No N/A**Qualified Welders:** Yes No N/A**Verified Joint Fit-up:** Yes No N/A**Approved Drawings:** Yes No N/A**Approved WPS:** Yes No N/A**Delayed / Cancelled:** Yes No N/A**Bridge No:** 34-0006**Component:** Hinge K Pipe Beams**Summary of Items Observed:**

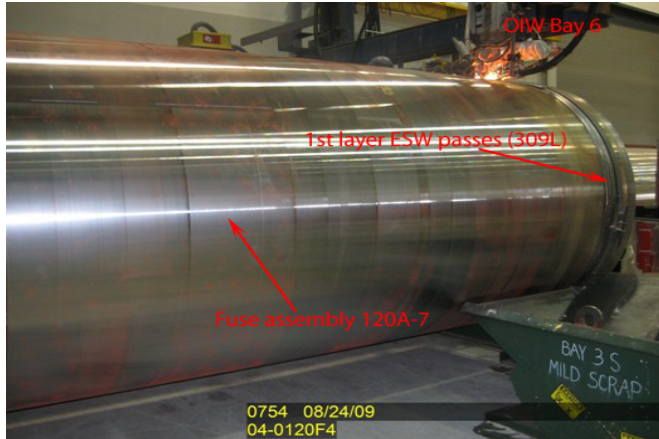
QA Inspector noticed that OIW had previously placed this forging assembly 102A-4 in position and was in-process of machining the completed stiffeners, utilizing a mechanical machining bit, as shown in attached picture below. QA Inspector had previously measured the stiffener heights to be approximately 662mm and noted that approximately 12mm of material (485W) was in process of being removed, to achieve a desired result of 650mm (+3mm/-10mm), which is in accordance to contract requirements. QA Inspector spoke with OIW machinist and OIW explained that the mechanical machining bit was set to remove approximately 1/32” (.8mm) of material (485W), per each cutting pass. QA Inspector noted that once the machining process is complete, OIW will perform dimensional measurements utilizing a laser tracker, prior to fitting the a109 (Post Tension Cap) plates. See attached picture below.
